Mourne Wall Restoration Project

Project Update (30th June 2017)

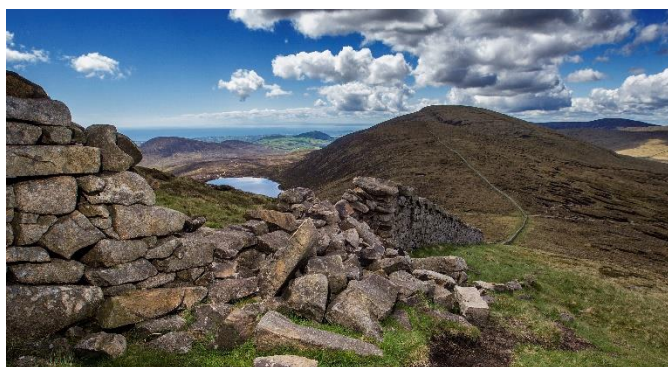
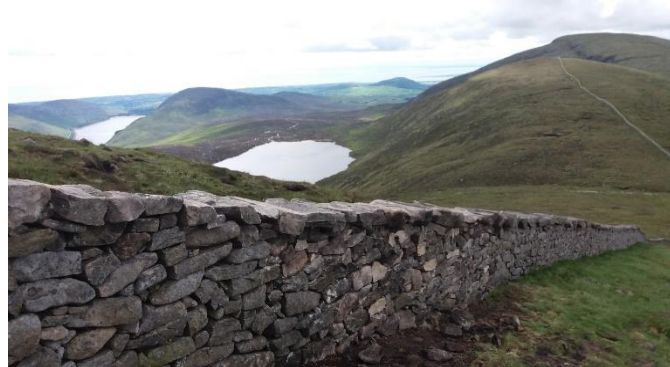
Less than one month on from project start, the first section of repairs – incorporating a 2.5km long section of the wall between Slieve Loughshannagh and Slieve Meelbeg – were completed (see before and after pics below) and the second section involving repairs on Slieve Meelmore were well underway.

Mourne Wall on Slieve Loughshannagh before and after repair work

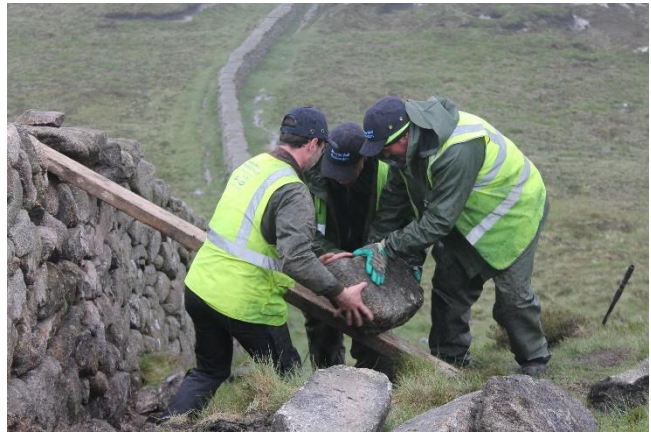
To date the work to repair the Mourne Wall has been carried out by local stonemasons from Thomas Rooney and Sons. So far no mechanical equipment has been employed with men walking the mountains daily and carrying out all repairs by hand. The stone needed for the repairs in the first two sections has been found lying adjacent to the wall and the team have been employing age-old construction methods such as using planks to roll the stones into place.

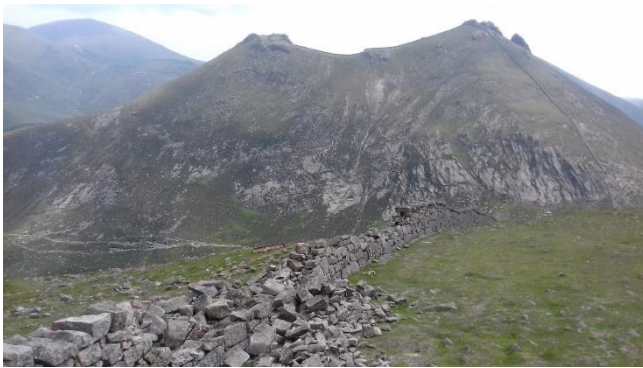
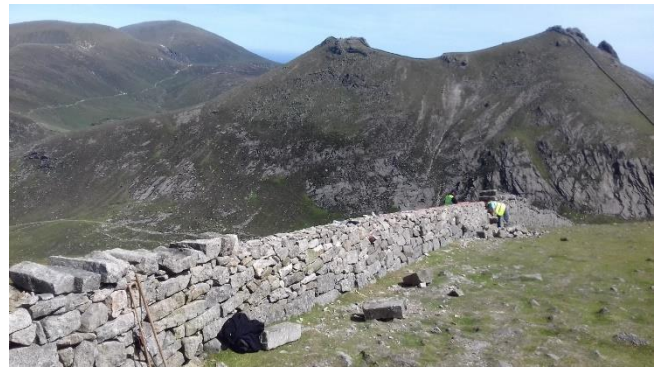
The team has just recently finished repairing a 20m collapse on Slieve Meelmore (see below) which it is believed was damaged by lightning some years ago.
